Fixing Toyota's accelerator pedal

Toyota says a simple mechanical fix – fitting a steel reinforcement bar in the accelerator pedal's mechanism – will eliminate excess friction that can cause the accelerator to stick open

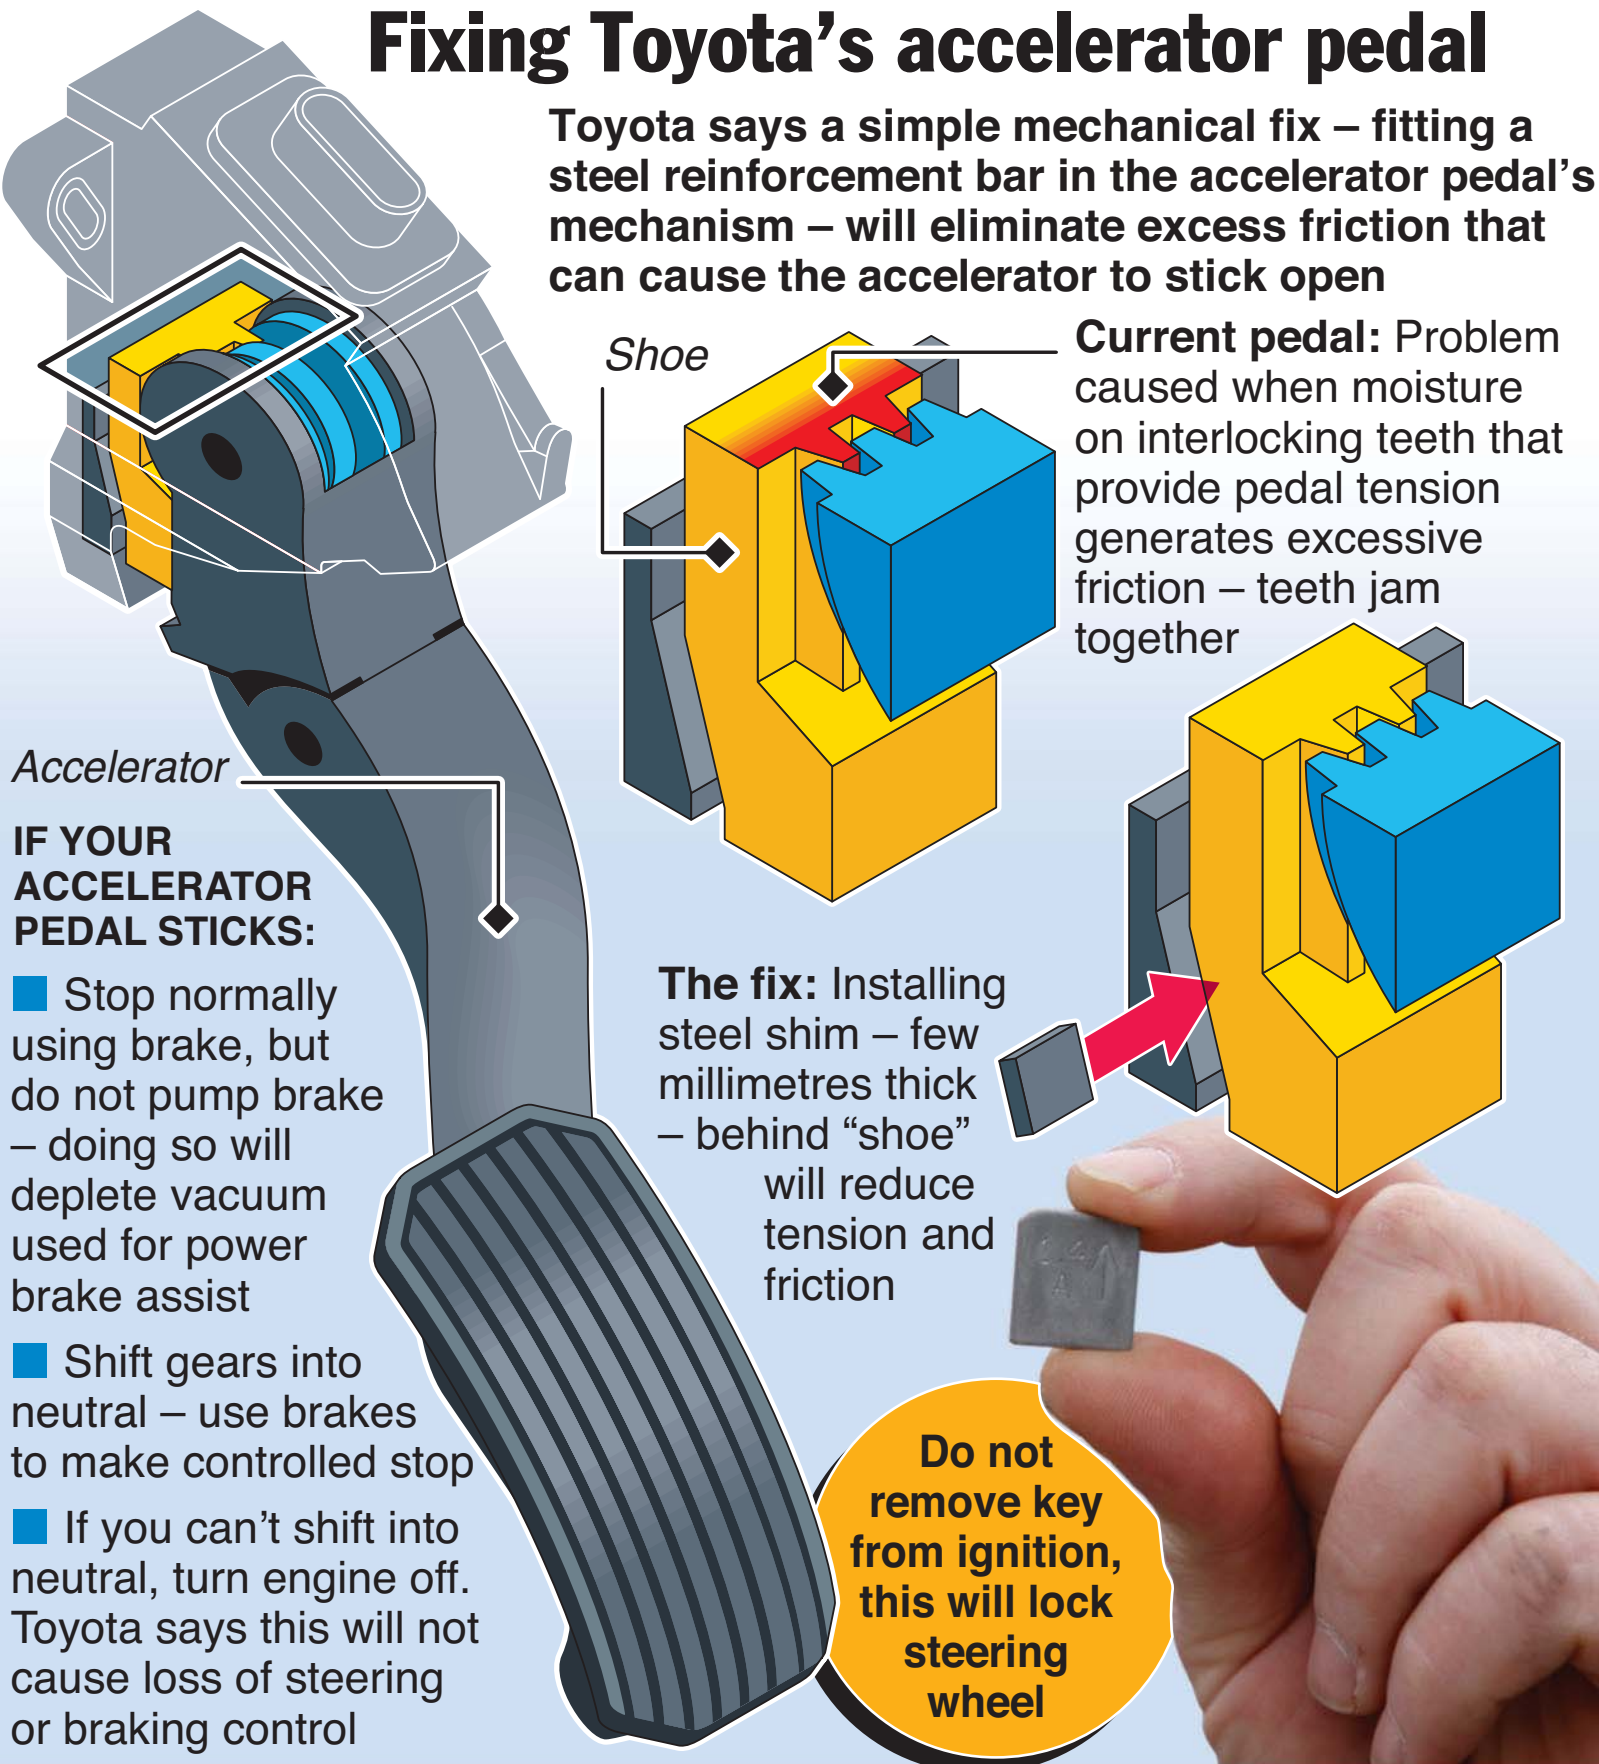
Current pedal: Problem caused when moisture on interlocking teeth that provide pedal tension generates excessive friction – teeth jam together

Accelerator

Shoe

The fix: Installing steel shim – few millimetres thick – behind "shoe" will reduce tension and friction

- Stop normally using brake, but do not pump brake – doing so will deplete vacuum used for power brake assist
- Shift gears into neutral – use brakes to make controlled stop
- If you can't shift into neutral, turn engine off. Toyota says this will not cause loss of steering or braking control
